Manhole Inspection Summary

Manhole # S150__002MH

Insp Date: **3/27/08 10:09 AM**

Location Address: **2699 ST. BENEDICT-DULANY**

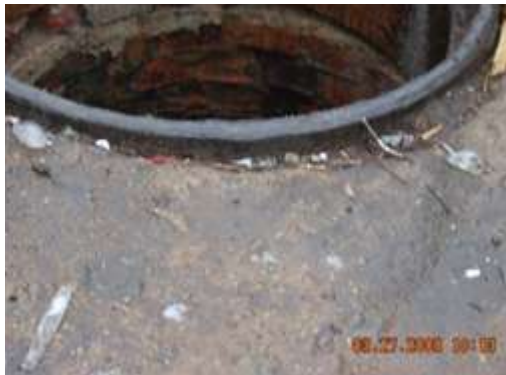
Miscellaneous

GRADE ADJ.

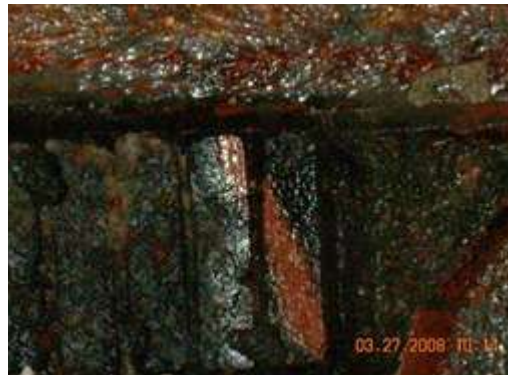
Defect 1

Condition: ☐ Sound ☐ Cracked ☐ Root Intrusion ☒ **Deteriorated** ☐ Leaks ☐ Debris

LOOSE BENCH BRICK

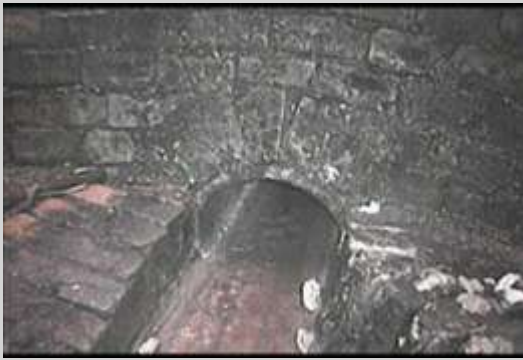
12 O'Clock Outflow

Pipe Height: **8.4** (in.) Rod and Bar (Angled)
Pipe Material: **Clay** ☐ Pipe Lined
Invert Depth: **10.85** (ft.) Flow Characteristics: **Slow**
Deposits: ☒ None ☐ Mud ☐ Sludge ☐ Debris ☐ Grease
Silt Depth: **0** (in.) Deposits Extent:
Infiltration: **None** Pipe Seal Cond: **Sound**

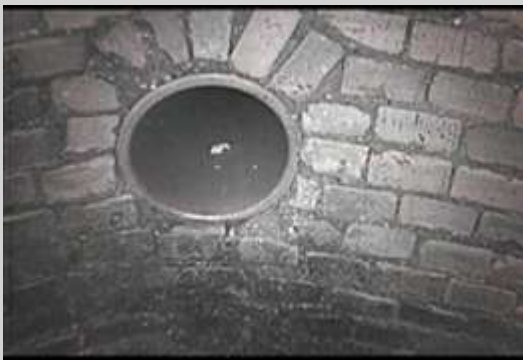
3 O'Clock Inflow

Pipe Height: **8.4** (in.) Rod and Bar (Angled)
Pipe Material: **Clay** ☐ Pipe Lined
Invert Depth: **8.85** (ft.) Flow Characteristics: **Slow**
Deposits: ☒ None ☐ Mud ☐ Sludge ☐ Debris ☐ Grease
Silt Depth: **0** (in.) Deposits Extent:
Infiltration: **None** Pipe Seal Cond: **Sound**

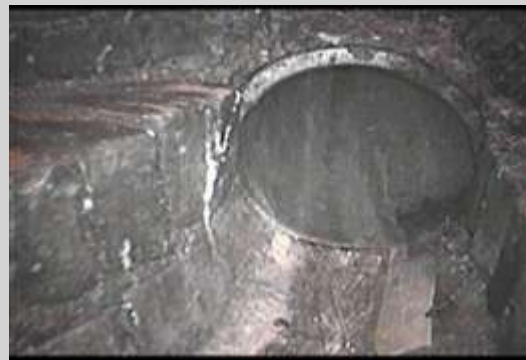
Drop In @ 3 O'Clock

Drop: **Outside** Rod and Bar
Angled: **Yes** Reading: **9.56** (ft.)
Inv Depth: **10.56** (ft.)
Drop Condition: **Open**

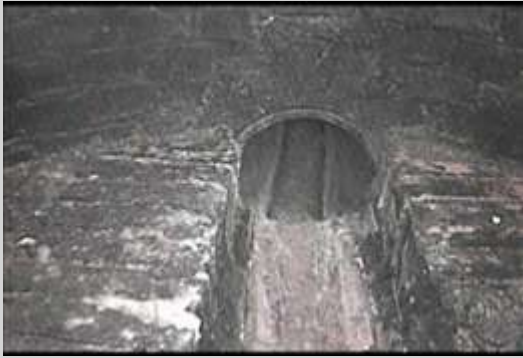
6 O'Clock Inflow

Pipe Height: **8.4** (in.) Rod and Bar (Angled)

Infiltration: **None** Pipe Seal Cond: **Sound**

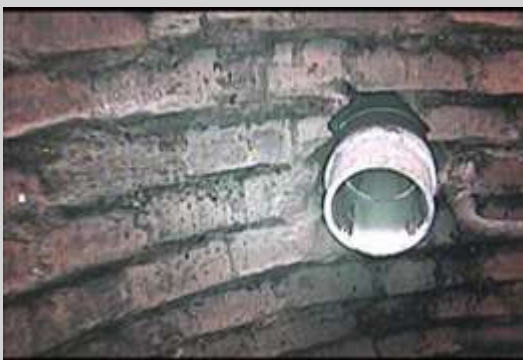
8 O'Clock Inflow

Pipe Height: **4.8** (in.) Rod and Bar (Angled)

Infiltration: **None** Pipe Seal Cond: **Sound**
